Test Report

Report No: TQT1057N07E-R1

Sample Name : PHOTO MOS RELAY, OPTOMOS RELAY, PHOTO COUPLER
Main Test Model : APY/GAQY210 Series
Additional Model : APY/ADY/GAQY/OPT0 Series, APV/ADV/GAQV/OPT1 Series, APW/ADW/GAQW/OPT2 Series, APH/APS/APC/APM Series, APPL/ATLP/ALP/AEL Series, 4N/6N/CNY/MOC Series.
Sample Received Date : Dec. 08, 2025
Testing Period : Dec. 08, 2025 To Dec. 22, 2025
Test Requested : Selected test (s) in the selected parts as requested by client with the RoHS 2 Directive 2011/65/EU Annex II (EU) 2015/863 as last amended by Directive (EU) 2017/2102.
Test Method : Please refer to next page(s).
Test Result : Please refer to next page(s).

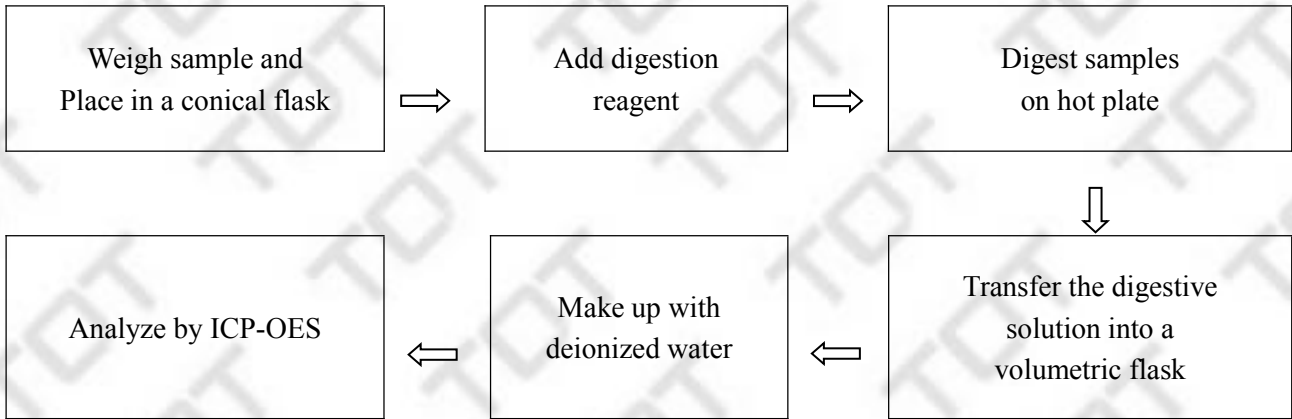
1. Test for Cd/Pb Content

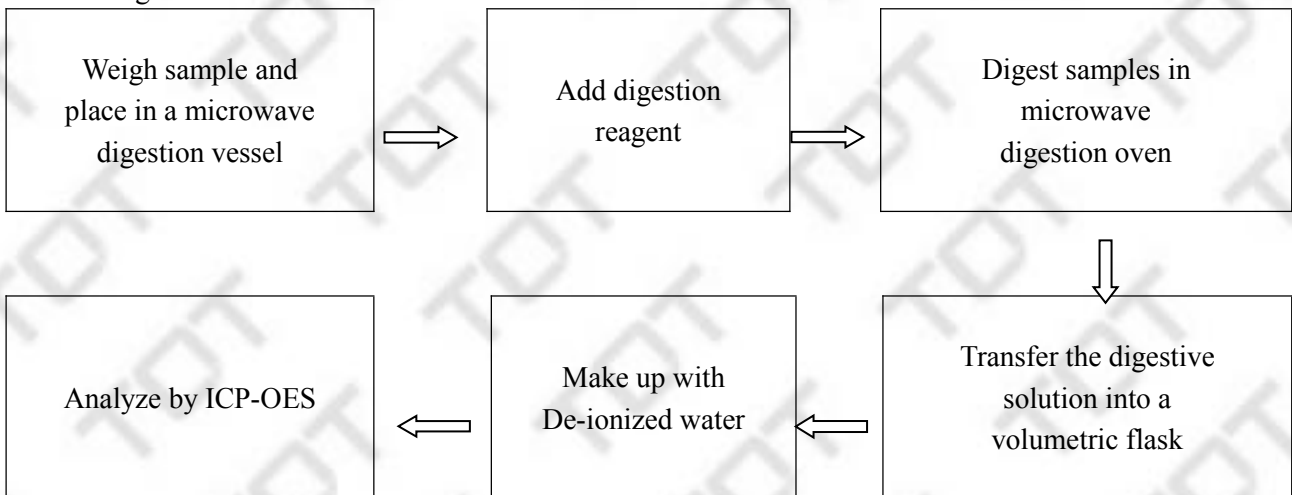
2. Test for Hg Content

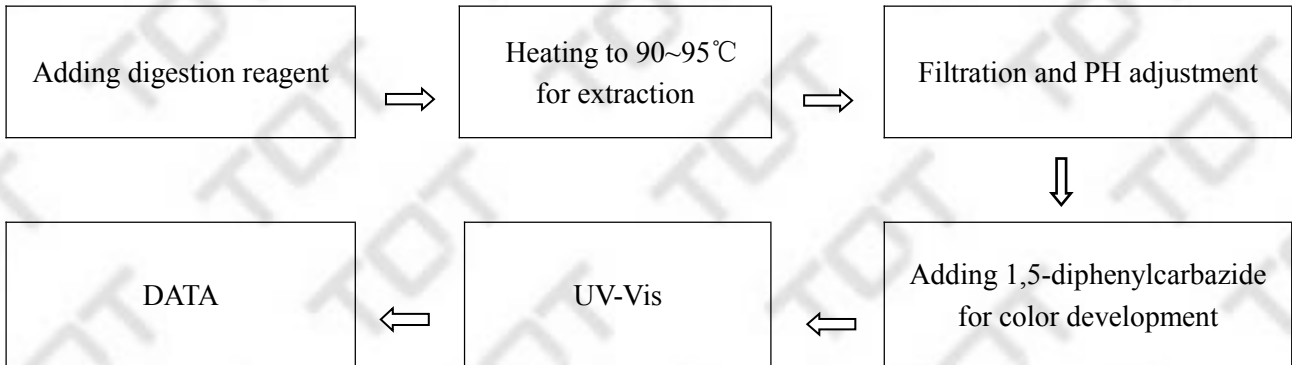
3. Test for Chromium (VI) Content

Nonmetal material

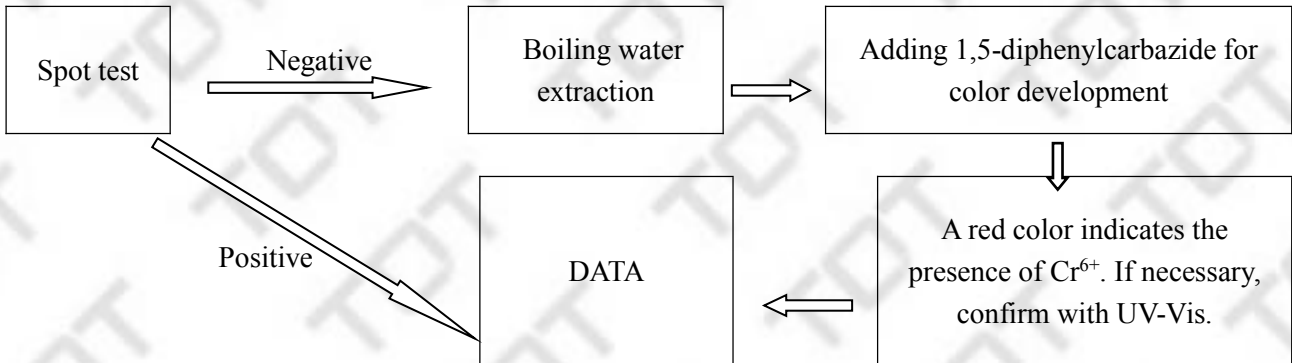
Metal material

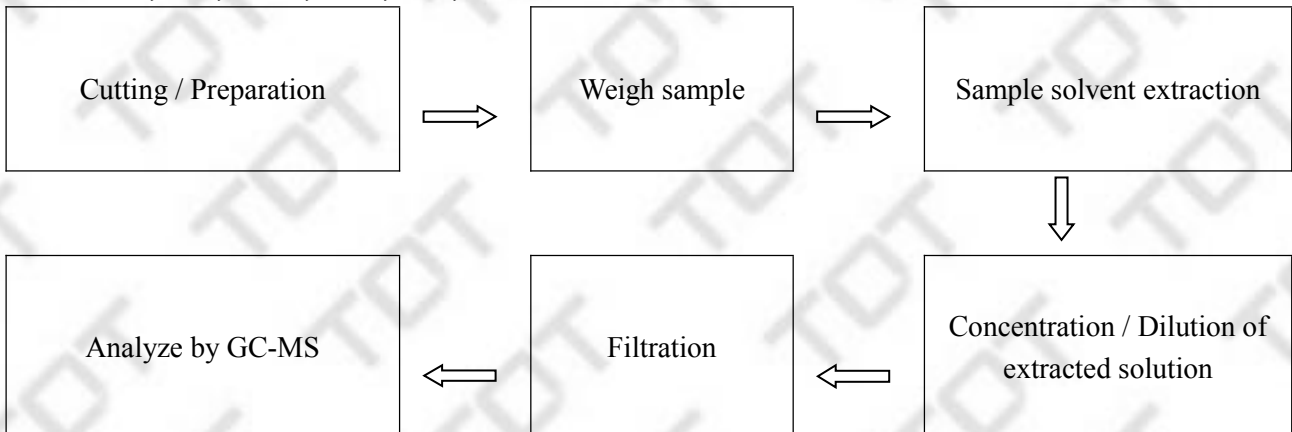
4. Test for DBP, BBP, DEHP, DIBP, PBB, PBDE Content
